# **In-house Engineering for Resolution of Chronic 4<sup>th</sup> Stage High Discharge Pressure Limitation on Carbon-dioxide Reciprocating Compressor**

Author: Mr. Ali Shallwani  
Designation: Machinery Engineer  
Organization: Engro Fertilizers Limited  
Date: 17<sup>th</sup> Jan, 2011

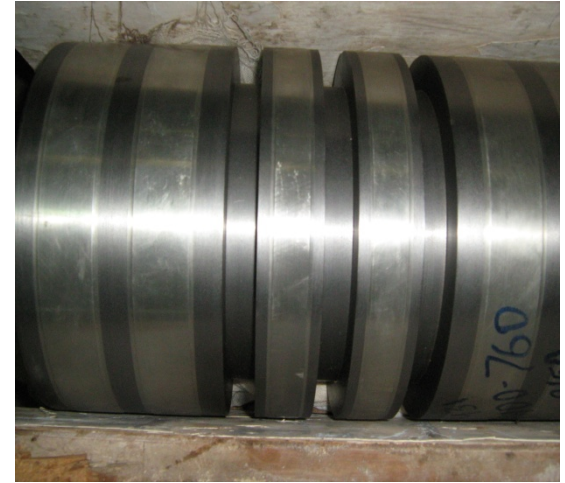
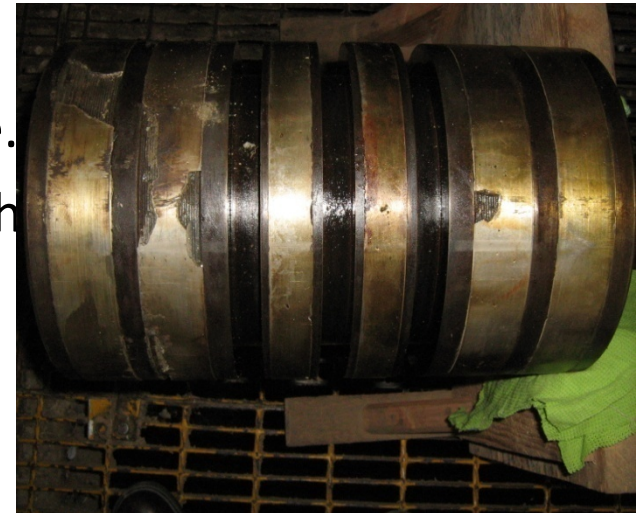
- Piston rings act as seal between the two compression compartments on the cylinder.
- Upon the failure of these rings, the gas from discharge stroke compartment will leak into suction stroke compartment.
- The ingress of high pressure gas will restrict the inlet stream of gas, and this resistance will cause an increase in the discharge pressure of the previous 4<sup>th</sup> stage.
- The failure of piston rings corresponds to the drop in the overall efficiency of the reciprocating compressor.
